Manhole Inspection Summary

Manhole # S21MM_010MH

Insp Date: **7/3/07 9:07 AM**

Location Address: **2729 FULTON-RICHLAND**

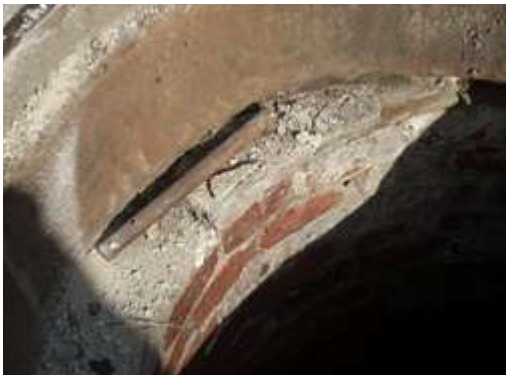
Defect 3

Condition: ☐ Sound ☐ Cracked ☐ Root Intrusion ☐ Loose Brick ☒ **Deteriorated**

DETERIORATION OF CHIMNEY

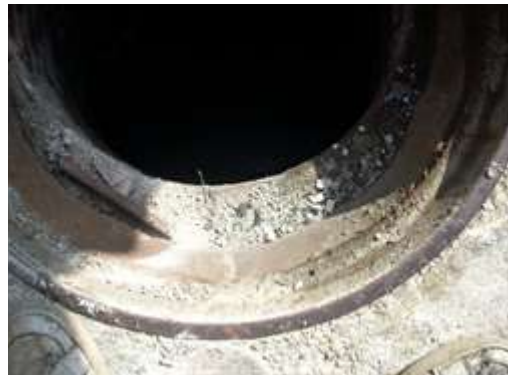
Defect 1

Offset: **3** (in.)

FRAME OFFSET

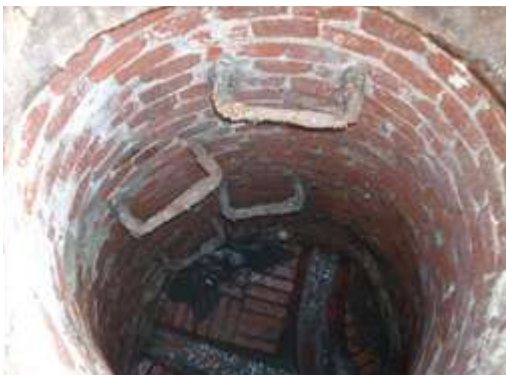
Defect 2

Count: **4** Missing: **0** ☒ **Corroded**

CORRODED STEPS

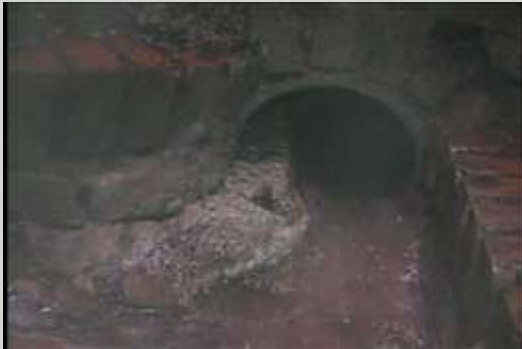
12 O'Clock Outflow

Pipe Height: **8.4** (in.) Rod and Bar (Angled)
Pipe Material: **Clay** ☐ Pipe Lined
Invert Depth: **9.31** (ft.) Flow Characteristics: **Slow**
Deposits: ☐ None ☐ Mud ☐ Sludge ☐ Debris ☒ Grease
Silt Depth: **4** (in.) Deposits Extent: **Medium**
Infiltration: **None** Pipe Seal Cond: **Sound**
